**Executive Summary:**

**Site/Project Location:** Spread 7 in Morton County

**Date of Inspection:** 10 November 2016

244 PU-14-842 Filed: 11/18/2016 Pages: 6  
Construction Inspection Report - 10 November 2016

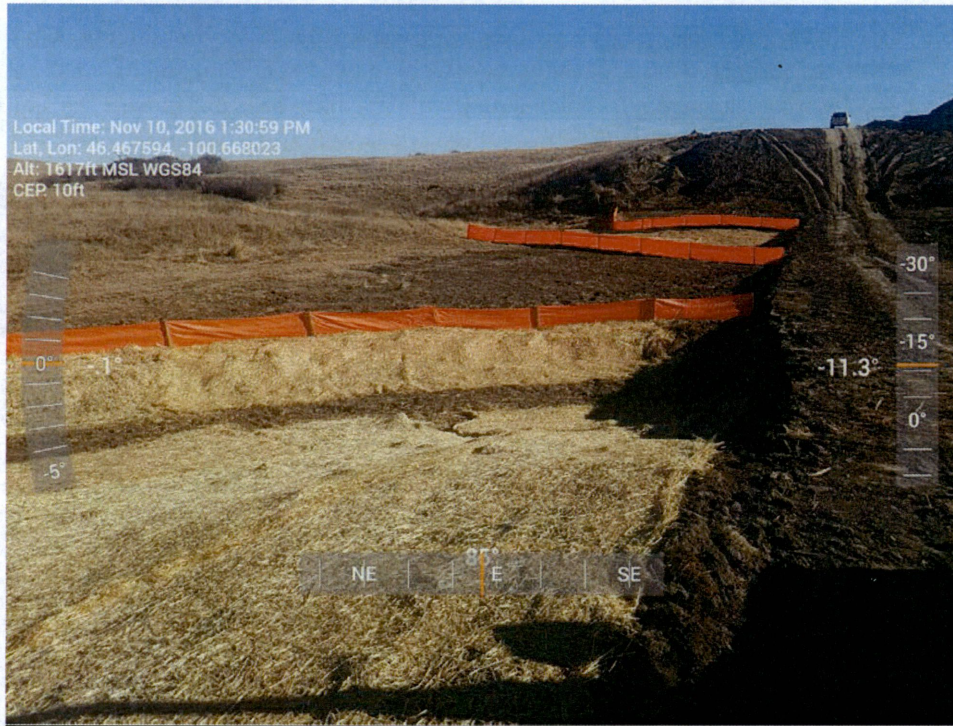
**Report Photo #1 Silt Fences and Erosion Matting Protecting Wetland**

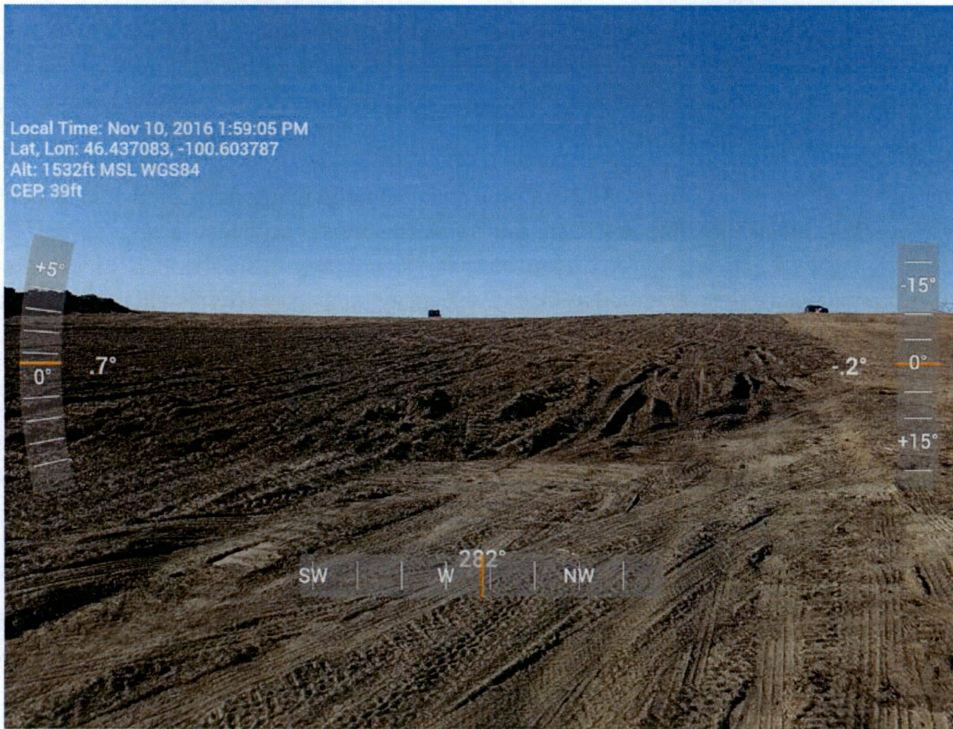
**Report Photo #2 Beginning of Topsoil Replacement**

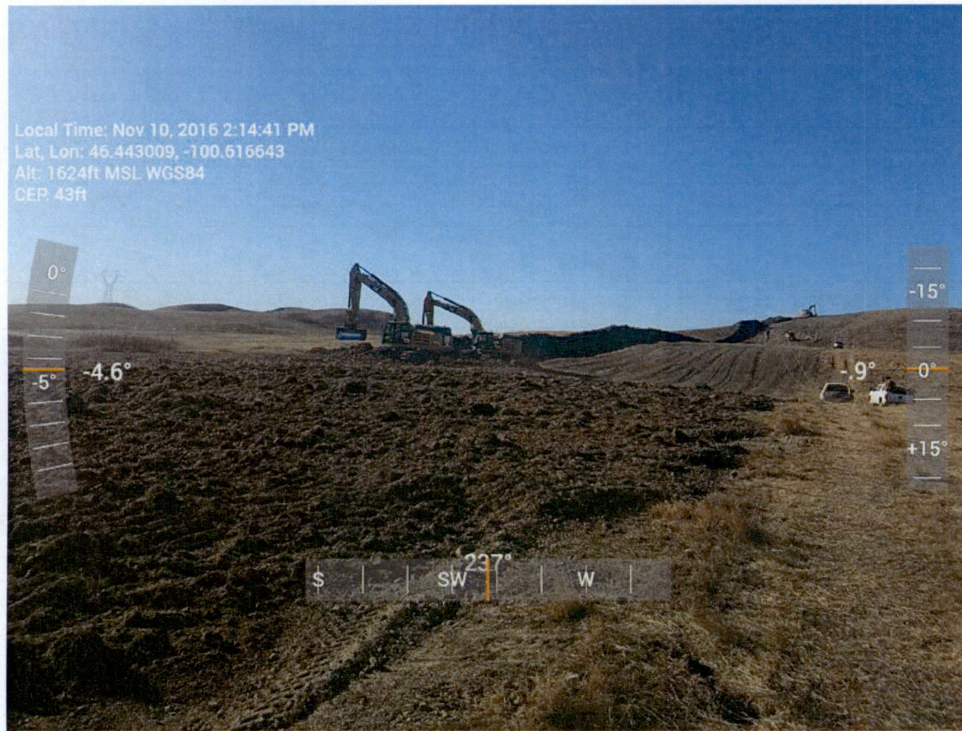
**Report Photo #3 Replacing Topsoil**

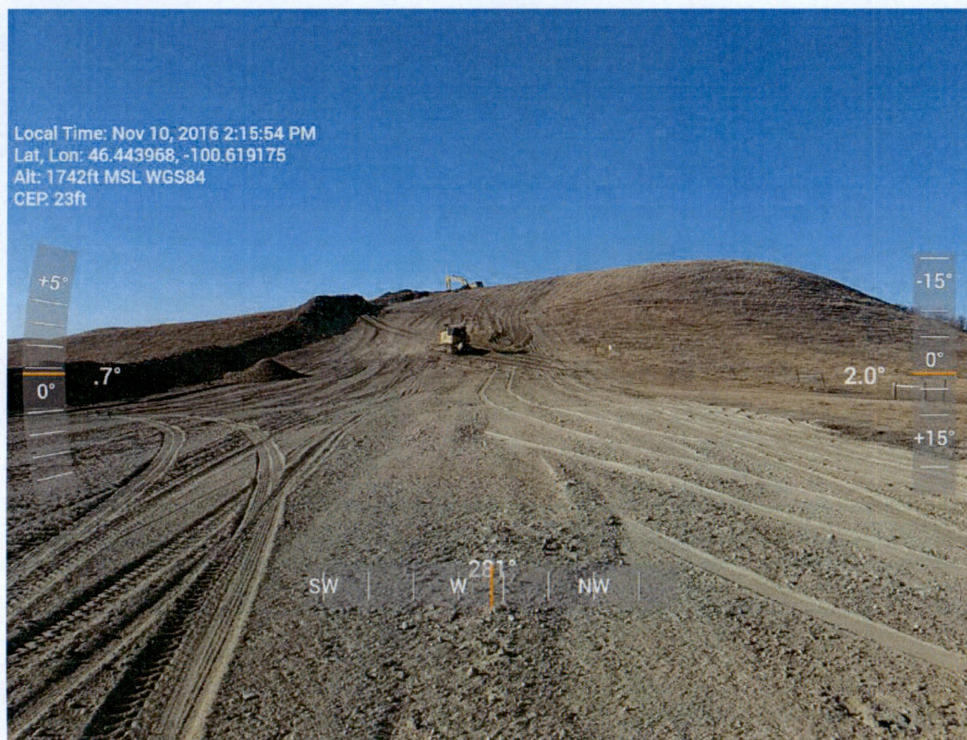
**Report Photo #4 Recontouring Hillside**

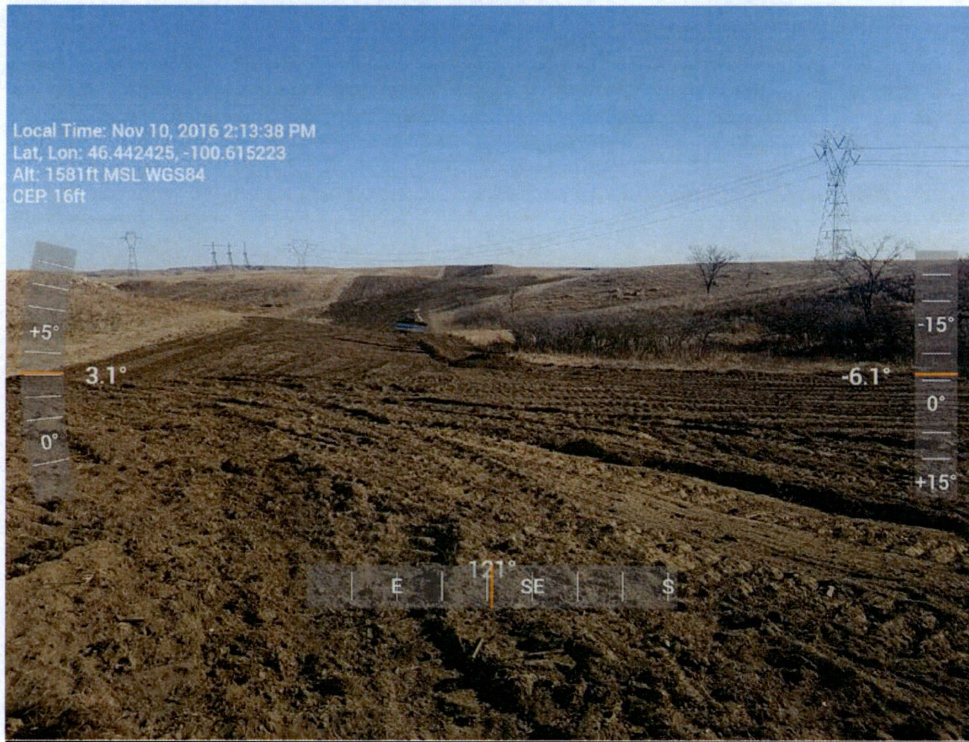
**Report Photo #5 ROW Narrowed for Wooded Area**

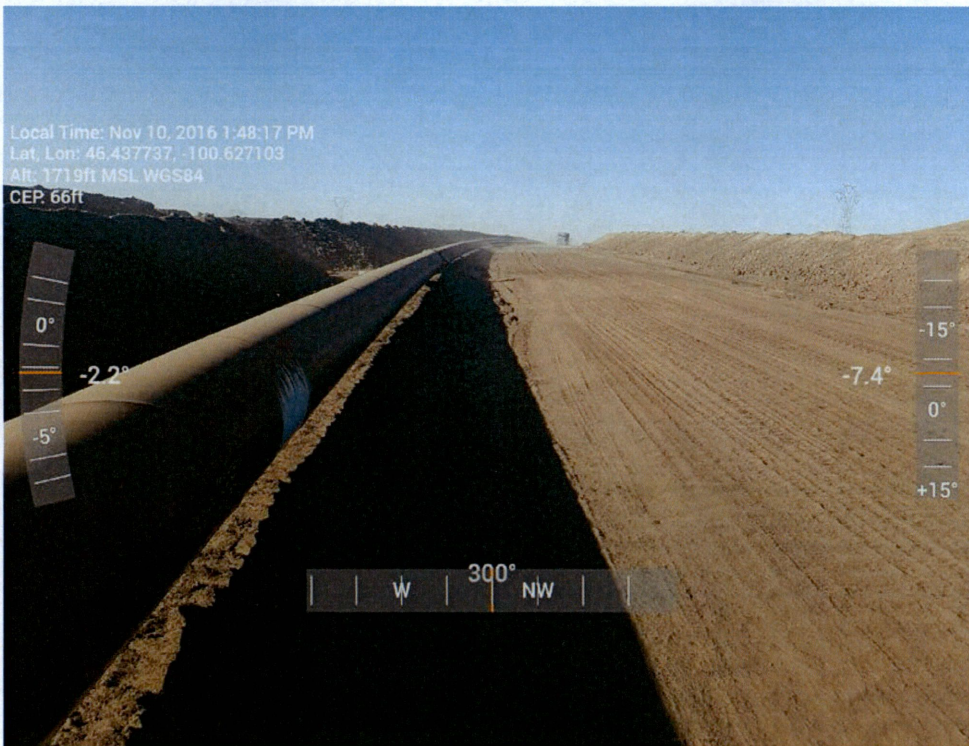
**Report Photo #6 Bore Pipe Staged for Lake Oahe HDD**

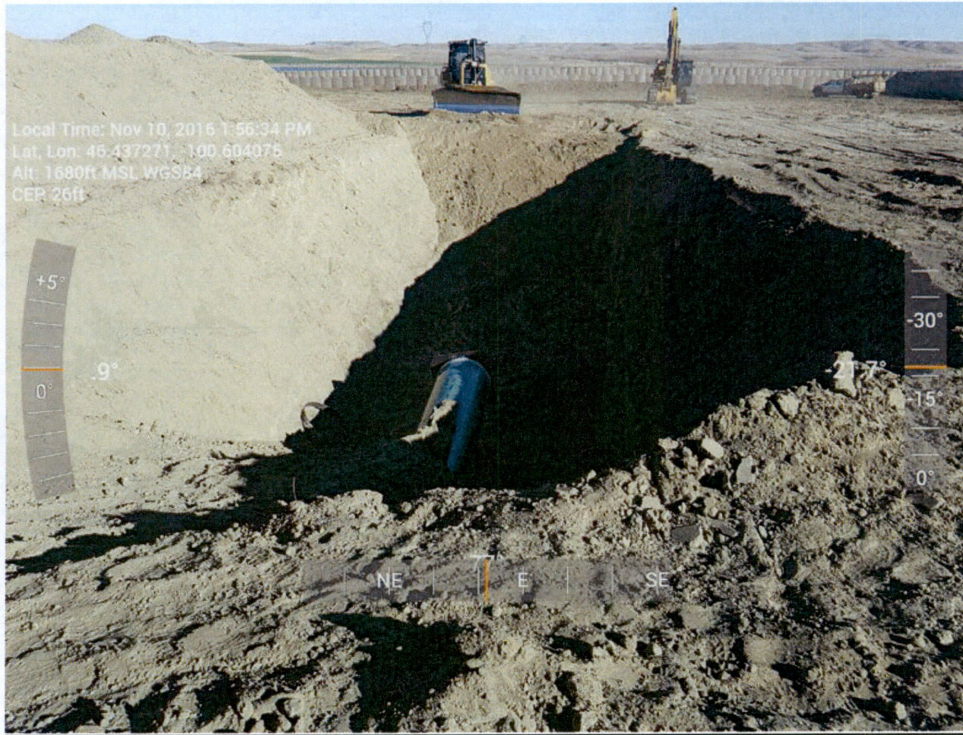
**Report Photo #7 Prepping Bore Pad and Bore Tie-in Area**

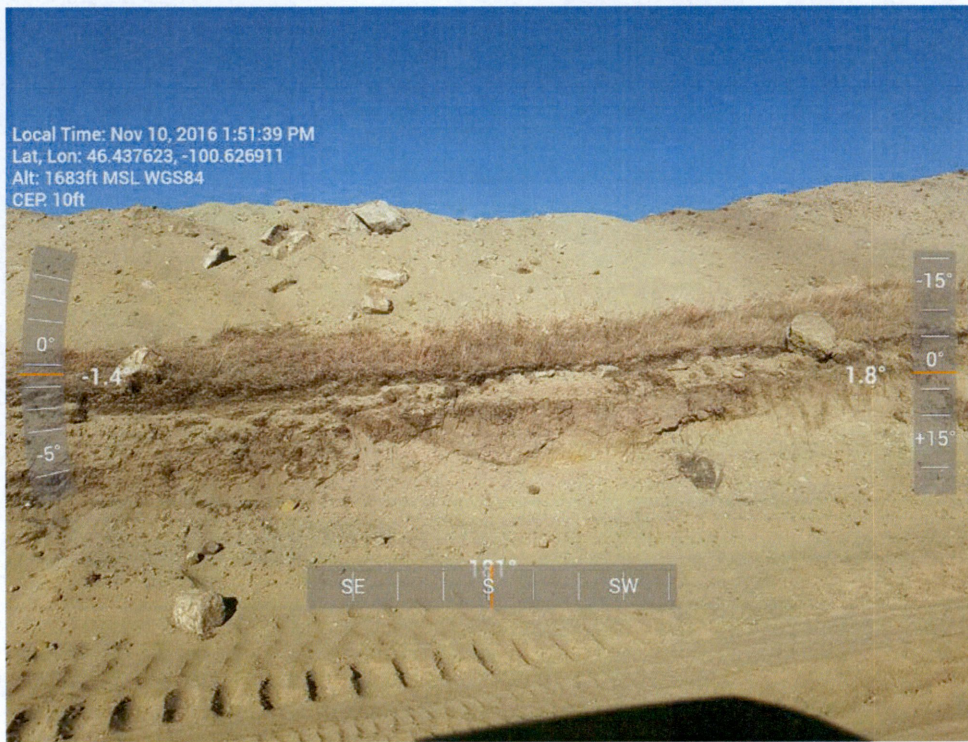
There were dry moats trenches dug along the bore pipe string staging workspace for the Lake Oahe crossing. They appeared to be outside of the temp workspace and traveled most of the length of the bore pipe. In some areas, the subsoil from the trench was placed on topsoil that was not previously stripped. (See Photo #8) Chris Grant of DAPL stated that they were installed as an extra security measure to help keep unauthorized persons from gaining access to the pipe. The trenches are located on property owned by Energy Transfer Partners.

"Dry moats" have been dug outside the approved work area for the Lake Oahe bore pipe strings. Subsoil from some of these pits have been placed on top of topsoil. All these areas are on reportedly DAPL owned land.

**Report Photo #8 Subsoil from Security Trench Placed on Topsoil**

Document items to PSC staff and complete follow-up actions as directed.
